NASA Technology Evaluation for Environmental Risk Mitigation
Kennedy Space Center, FL 32899

Gas Dynamic Spray Technology Demonstration Project Management

**Final Joint Test Report
June 30, 2011**

Gas Dynamic Spray Technology Demonstration

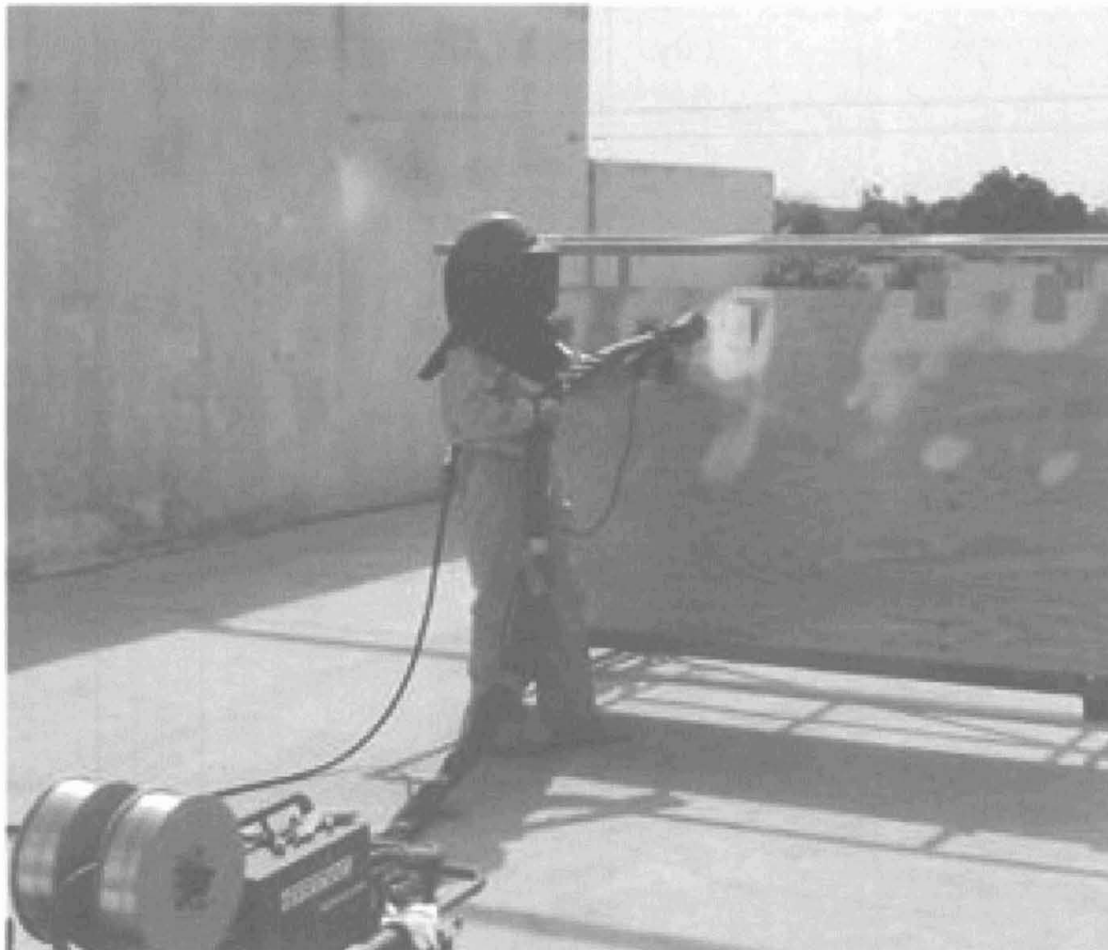
Figure 4 Zinc TSC Application

The L3 Corrosion Control Group working out of Patrick Air Force Base (PAFB), FL, provided their services for the TSC (Figure 4) and GDS (Figure 5) applications. Representatives from the NASA Corrosion Technology Laboratory located at Kennedy Space Center (KSC) were present to observe and record the application process.

The Zn TSC easily achieved a 10+ mils coating thickness by applying at least three alternate criss-cross patterns with each pass applying three-four (3-4) mils of coating thickness. The Zn GDS coating thickness was achieved by at least eight (8) multiple criss-cross patterns adding one-two (1-2) mils per pass. The spray pattern (~0.5" wide) and amount of overlapping passes took on average five (5) times as long to coat compared to the TSC operation.

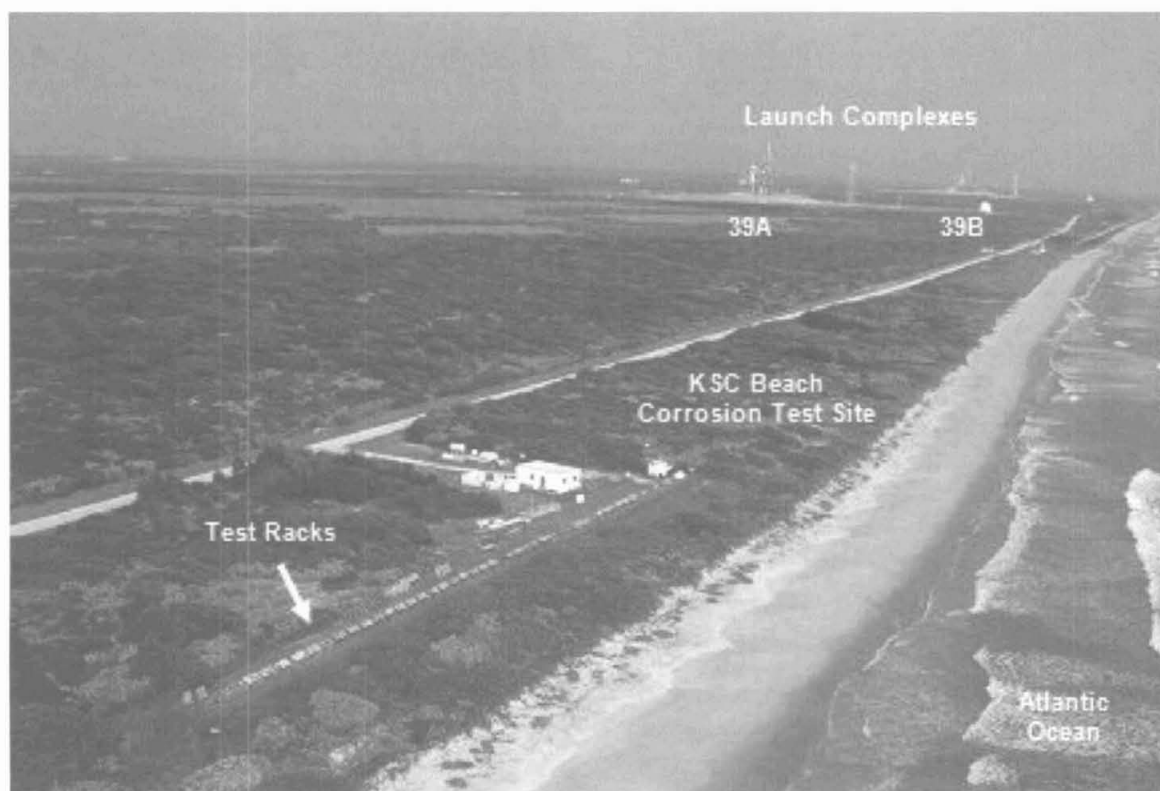
Figure 7 KSC Beach Corrosion Test Site

Once the final preparations were completed, the test panels were mounted on test racks and transported to the KSC Beach Corrosion Test Site. The test racks and stands utilized for this project have been used for previous corrosion projects and were designed according to ASTM G 50, "Standard Practice for Conducting Atmospheric Corrosion Tests on Metals".

The distance of the test stands from the mean high tide line is approximately 100 feet (30 meters). The site is located approximately 1.5 miles south of Launch Complex 39A directly on the Atlantic Ocean (Figure 7). The site provides an aggressive and very corrosive high salt, high humidity, high ultra-violet light Florida seacoast environmental exposure for test articles.
